RESTORATION
PROPOSAL
FOR
JORBANGLA,
TERRACOTTA
TEMPLE AT
ITONDA,
BIRBHUM,
WEST BENGAL.

INDIAN
NATIONAL
TRUST FOR
ART &
CULTURAL
HERITAGE

RAJATRAY
WITH BISWADIP SEN & TEAM.
JUNE, 1997

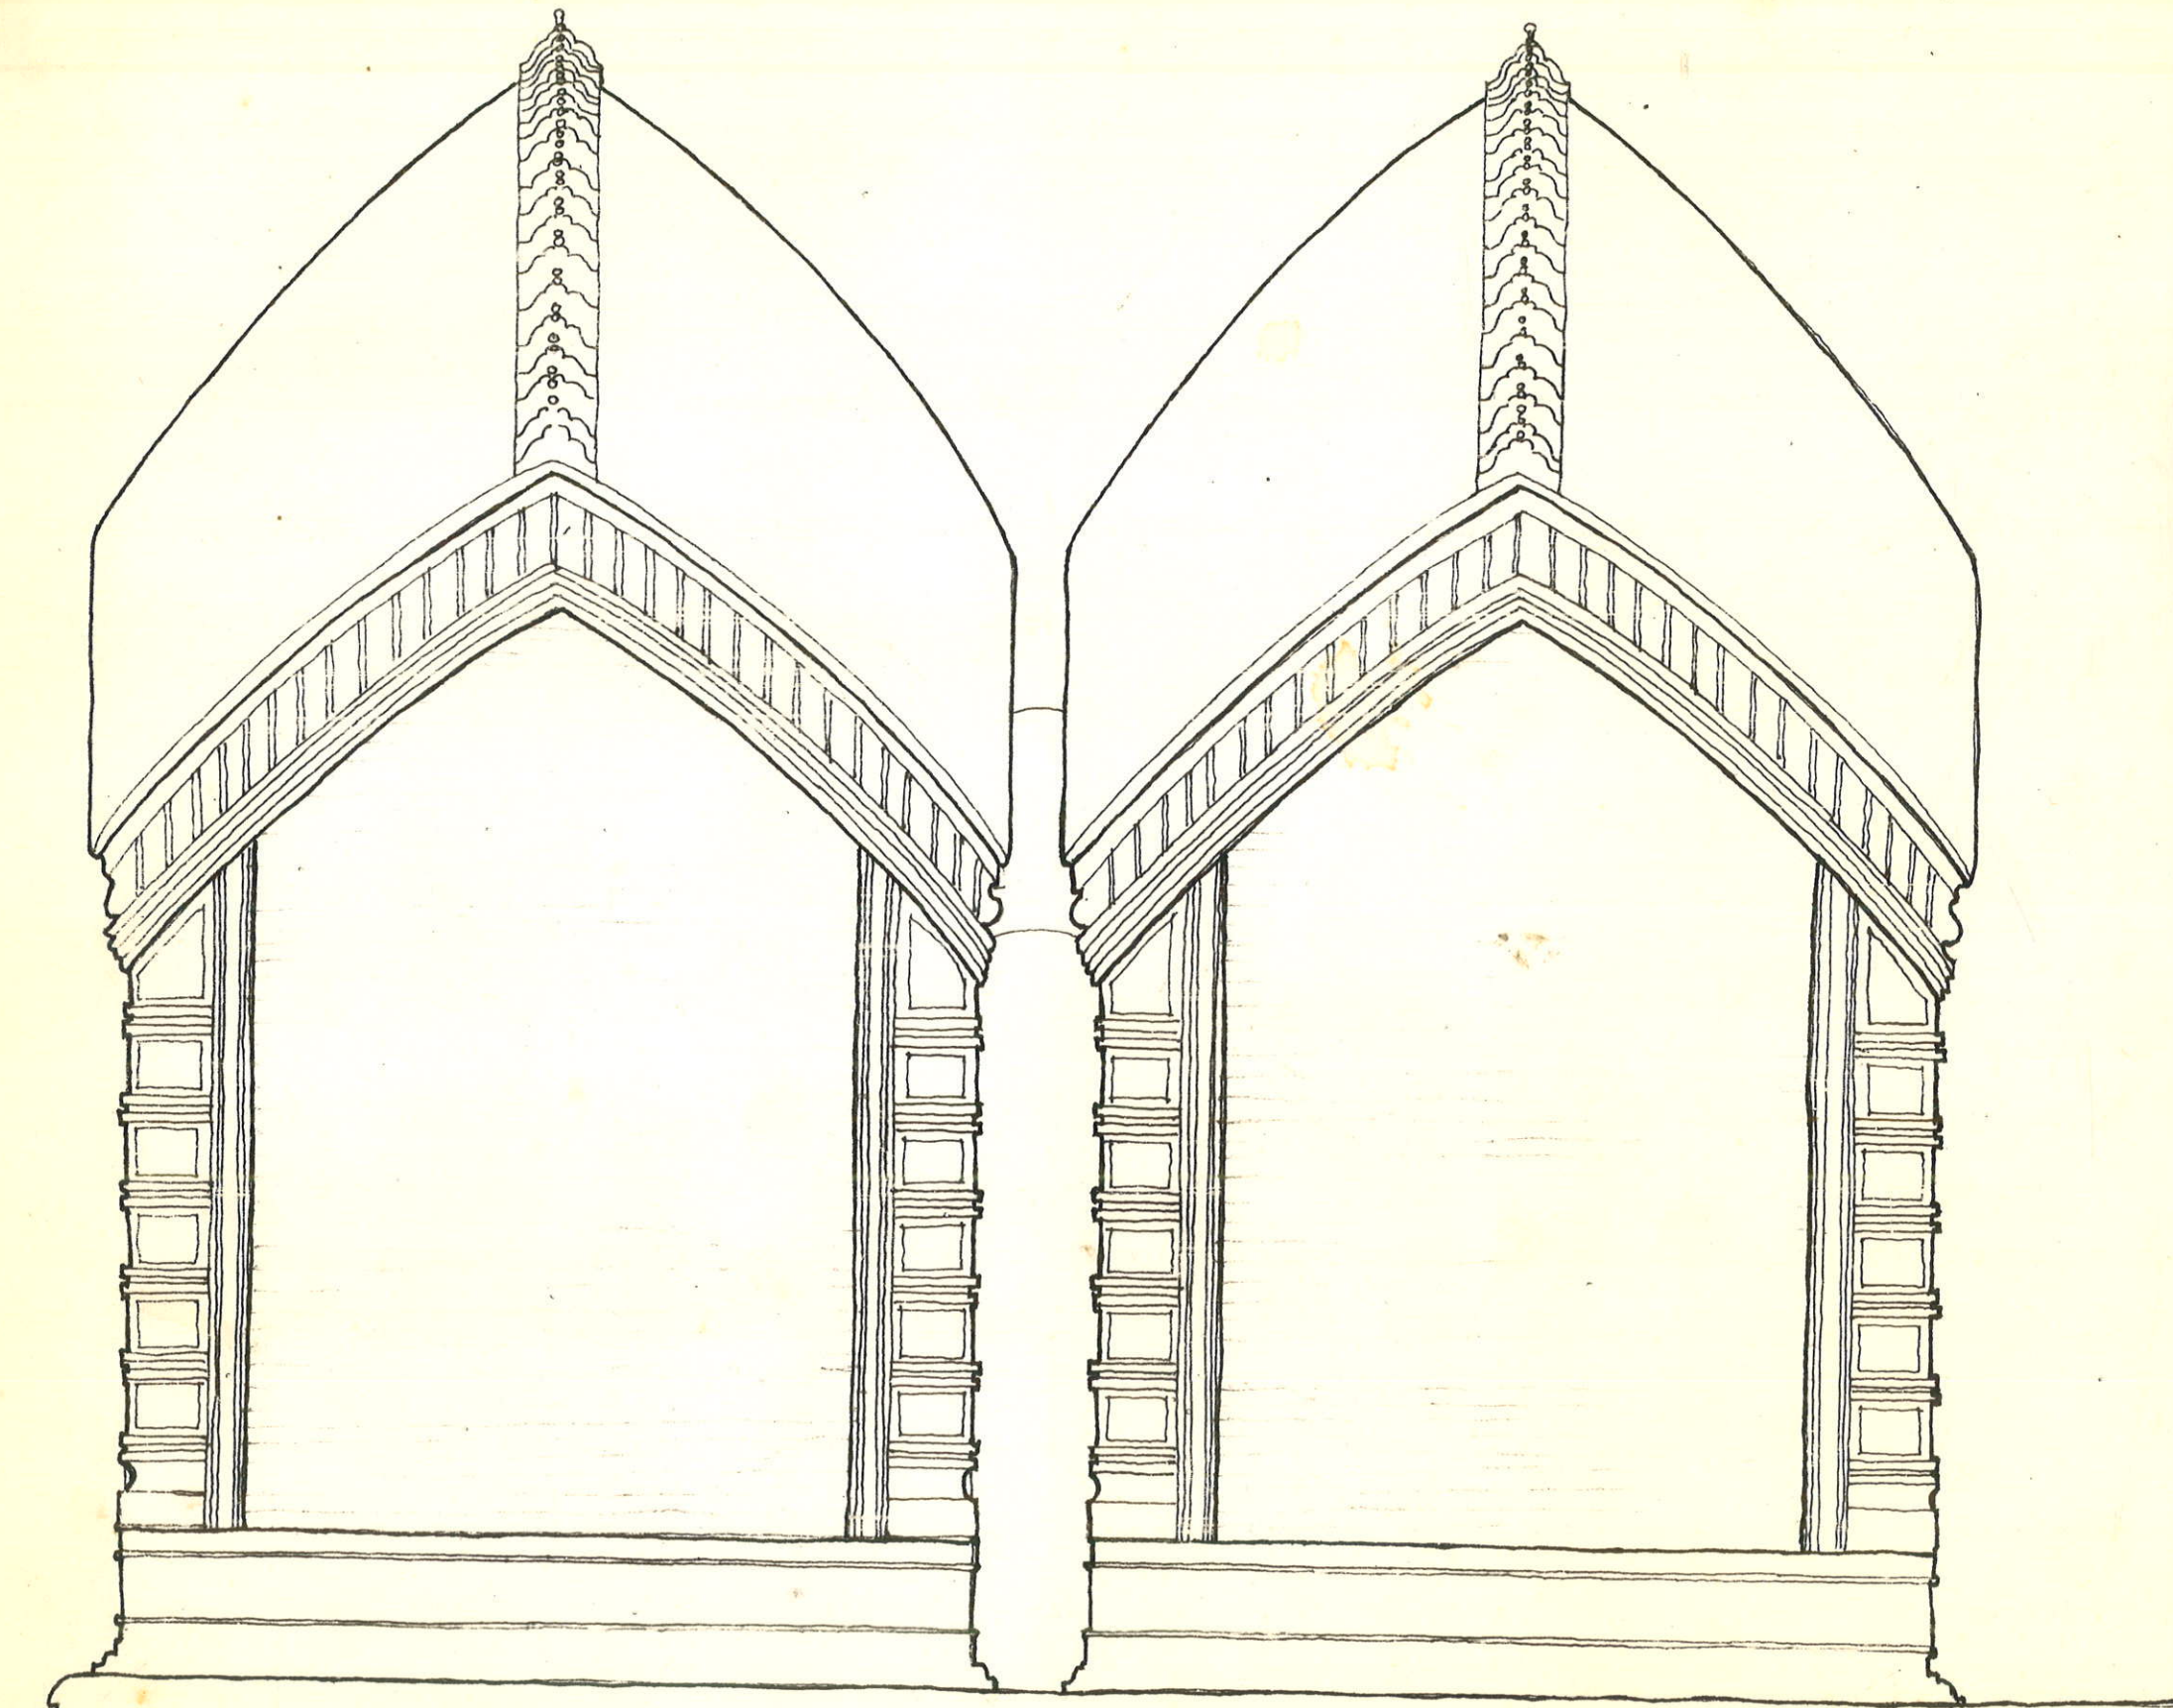
WEST SIDE ELEVATION, CONJECTURALLY RESTORED.
